COSTARCHEM'S POLYURETHANE PRODUCT WAS USED TO WATERPROOF THE ROOF GUTTER OF 160SQM AT CAMEROON COURT, IKOYI LAGOS.

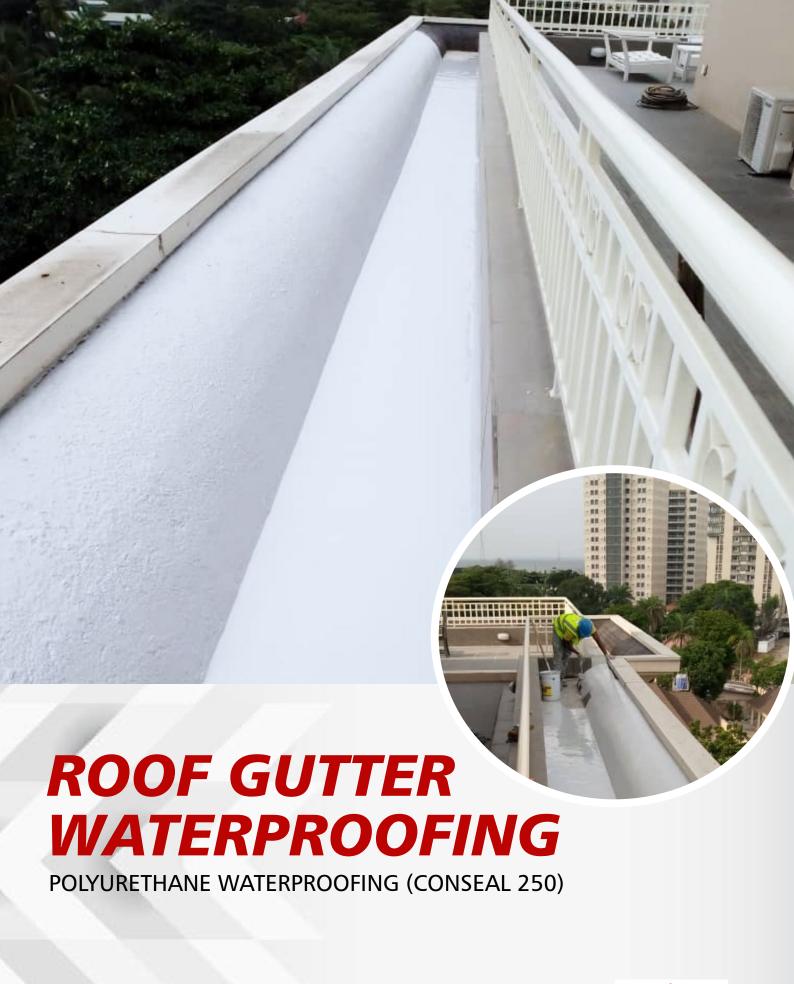
Costarchem were contracted to evaluate a property at Ikoyi Lagos. During inspection, the team observed cracks, random leakages, cracks at joints, a bad slope causing water to sit on the roof gutter and a bad screed (no bonding/loose sand) on the roof gutter despite the use and presence of an acrylic waterproofing membrane.

The team resolved the problem by carting out the old screed and doing a new screed Afterwards, the surface was primed and allowed to sit for 30 minutes before applying the first coat of the polyurethane waterproofing membrane (Conseal 250) with geotextile fibres applied at the joints. The next day, the second coat of Conseal 250 was applied to permanently waterproof the roof gutter.
